CONDITIONS ASSESSMENT REPORT AND RECOMMENDATIONS

LELAND TOWNSHIP PUBLIC LIBRARY

Leland, MICHIGAN

31 MAY 2019

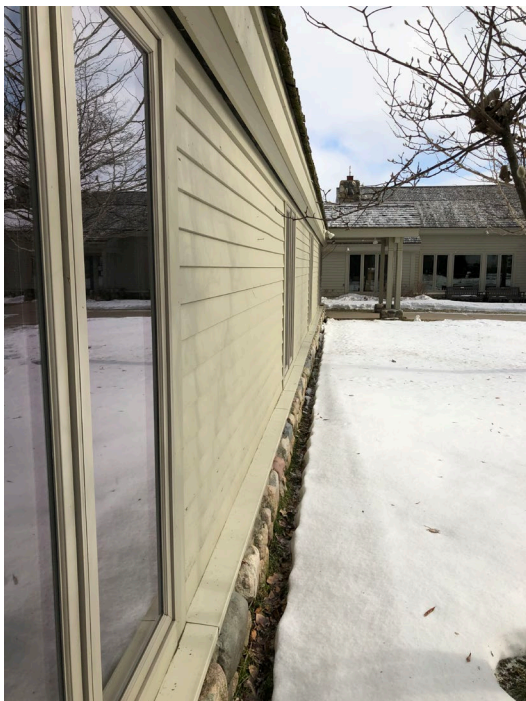
There are no existing gutters and very little overhang on the existing room. This results in a roof dripline very close to building perimeter. There has been water infiltration in to various areas of the crawl space during heavy rains. Although re-grading of the entry façade has been done, the addition of pea-gravel and drain pipe at the building base could remediate existing water issues.

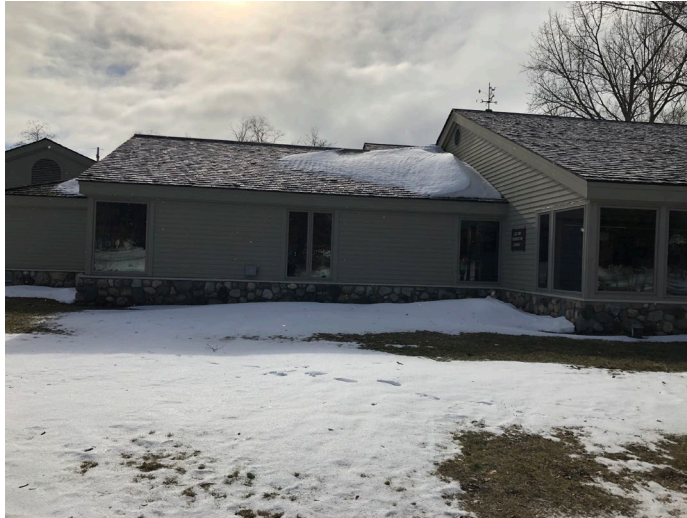
The Library has a cedar wood-shake shingle roof. The wood shingles over the library are in poor condition and need to be replaced. No gutters were observed.

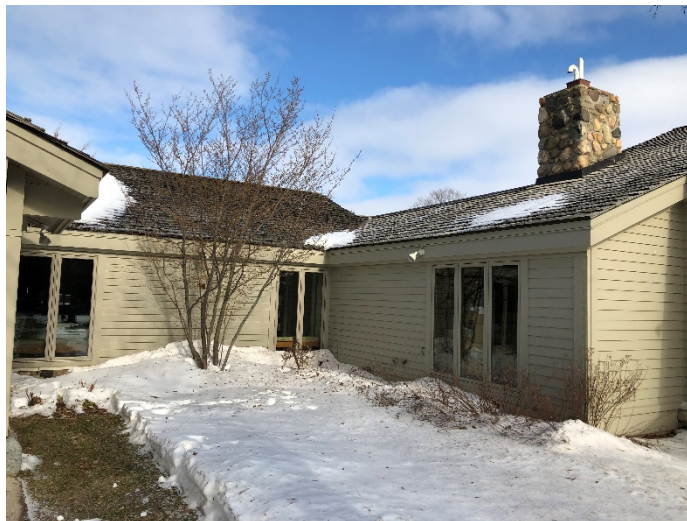
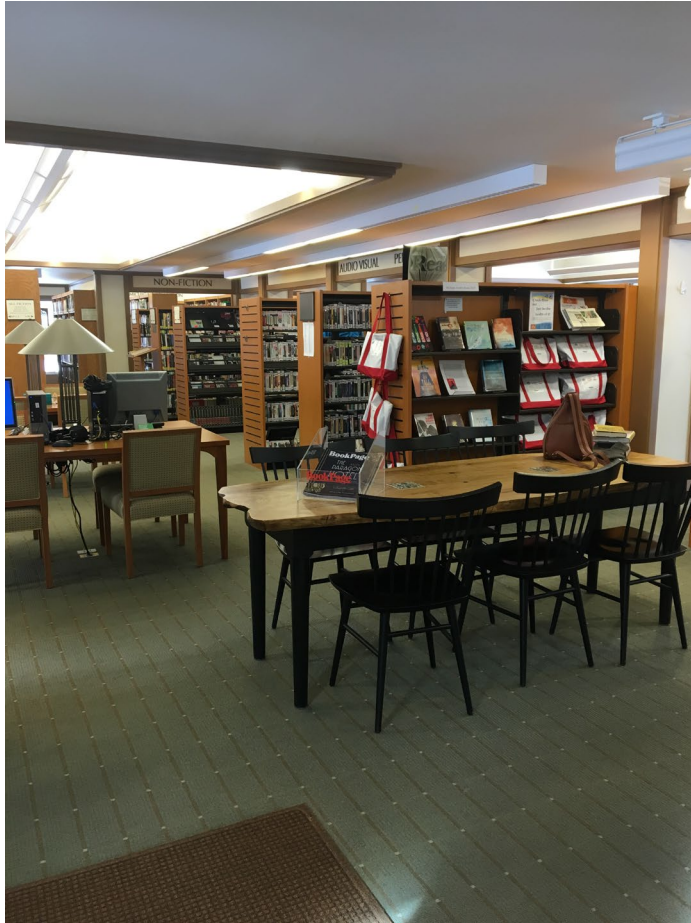
The Library has one large stone chimney that is used for mechanical venting. This chimney was on the original library exterior wall but has since become an interior feature after the Museum addition to the library building. It is now an interior feature of the Munnecke Room.

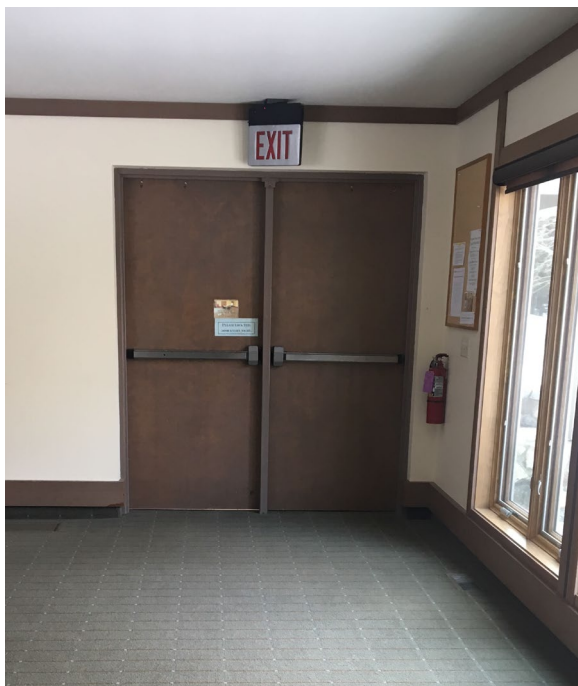
The interior is in good condition overall, showing typical wear. The vestibule walk-off mat is in fair condition and could be replaced. The floor in front of the circulation desk between the entry vestibule and youth area shows signs of shifting under the carpet with some minor leveling issues. There are seasonal water issues near the vestibule, not observed at the time of site visit.

The majority of the spaces feature carpet tile flooring. Carpeting exhibits typical signs of wear for its age and could be replaced. Walls are painted gypsum board and in good condition. Walls have a wood base with carpet base recessed below the wood base.

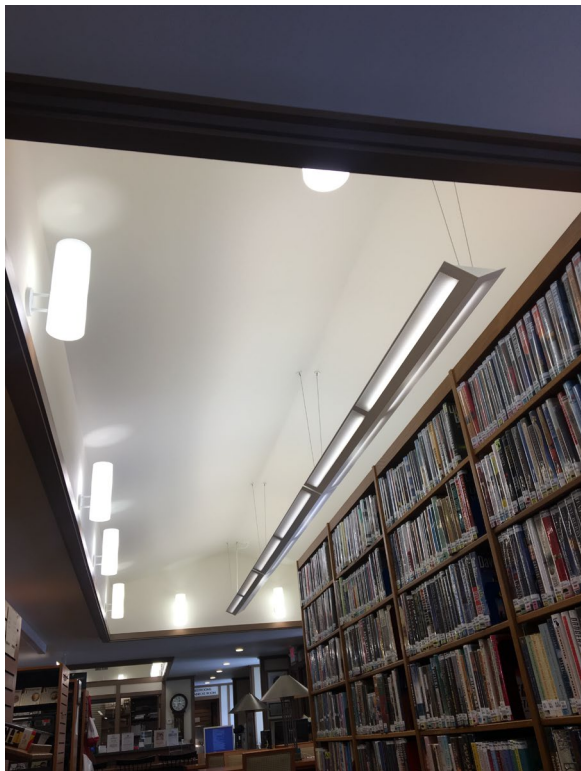
The ceilings are all hard – most likely gypsum board finish and painted. There are 3 gable ceiling coffers in the library space: two over stacks and one over the staff and youth area. There is also a gable ceiling coffer in the Munnecke Room. Refer to PME Study Report for lighting.
